# Nonpoint Source Implementation Strategy Plan for Chocolate Run-Mahoning River HUC-12 (05030103-04-06)

*Approved: August 14, 2019*

*Version 1.0*

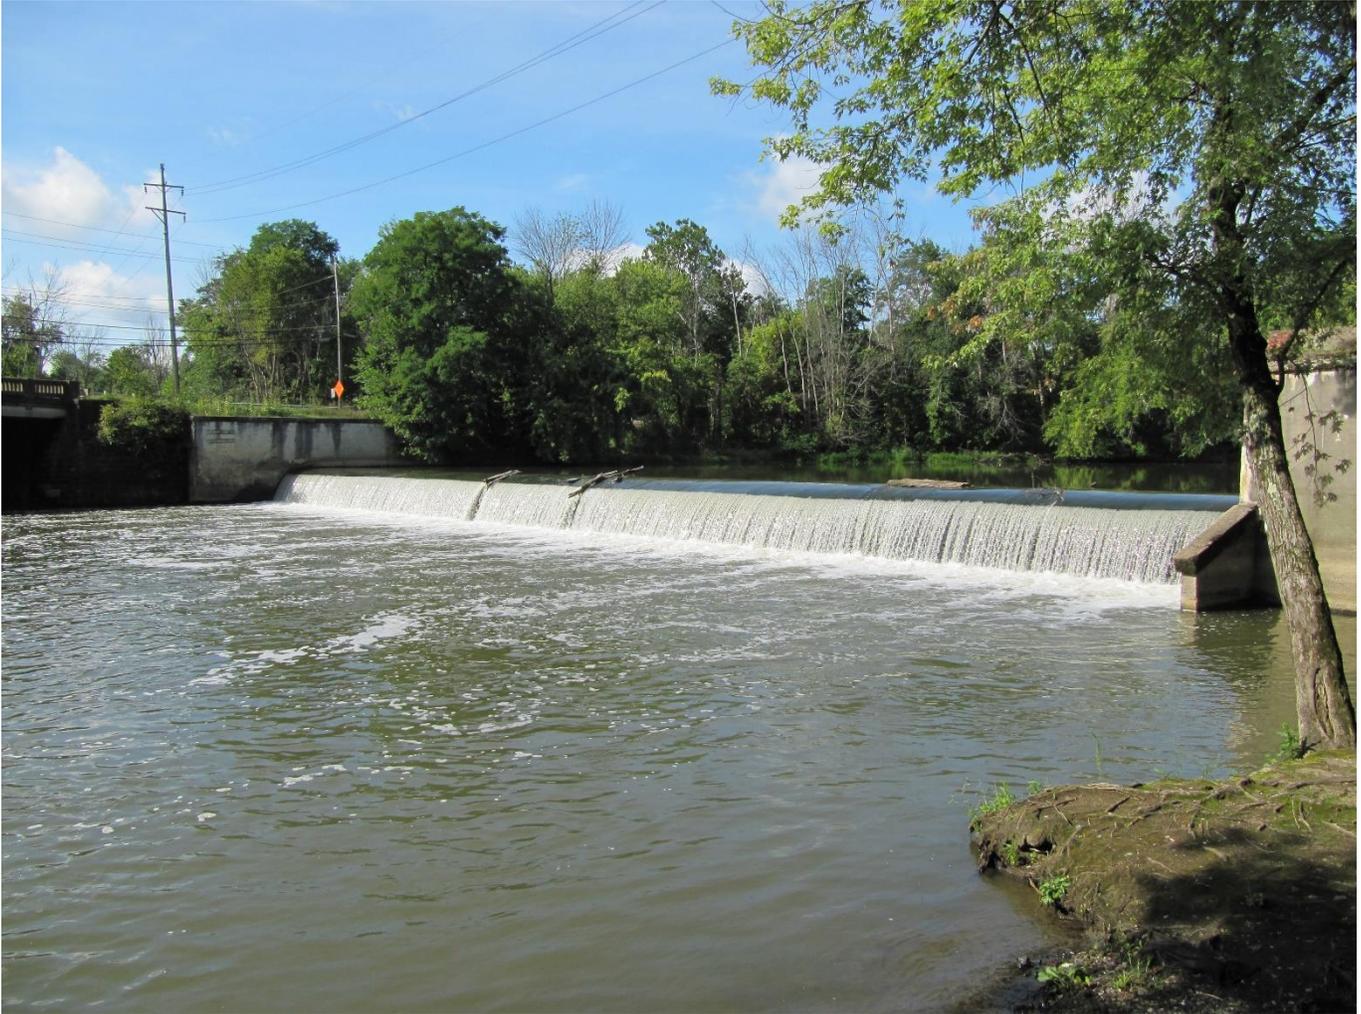
*Leavittsburg Dam (photo courtesy Eastgate Regional Council of Governments)*

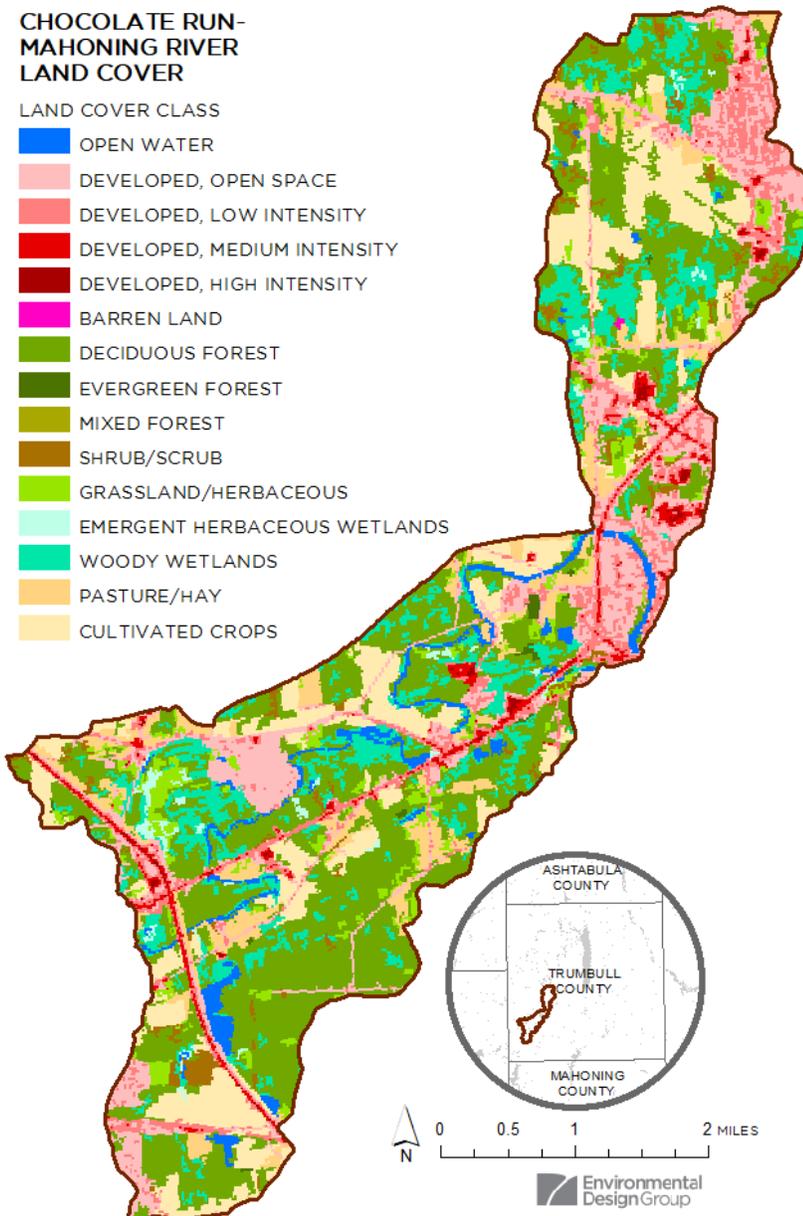
NLCD Land Cover	Acres	Percent of HUC-12
Deciduous Forest	3660.5	34.5%
Cultivated Crops	1448.5	13.7%
Developed Open Space	1390.9	13.1%
Woody Wetlands	1142.6	10.8%
Developed Low Intensity	888.2	8.4%
Hay/Pasture	673.1	6.4%
Herbaceous	429.0	4.0%
Open Water	321.6	3.0%
Developed Medium Intensity	233.0	2.2%
Shrub/Scrub	224.4	2.1%
Emergent Herbaceous Wetlands	99.8	0.9%
Developed High Intensity	49.1	0.5%
Evergreen Forest	31.6	0.3%
Barren Land	2.7	0.03%

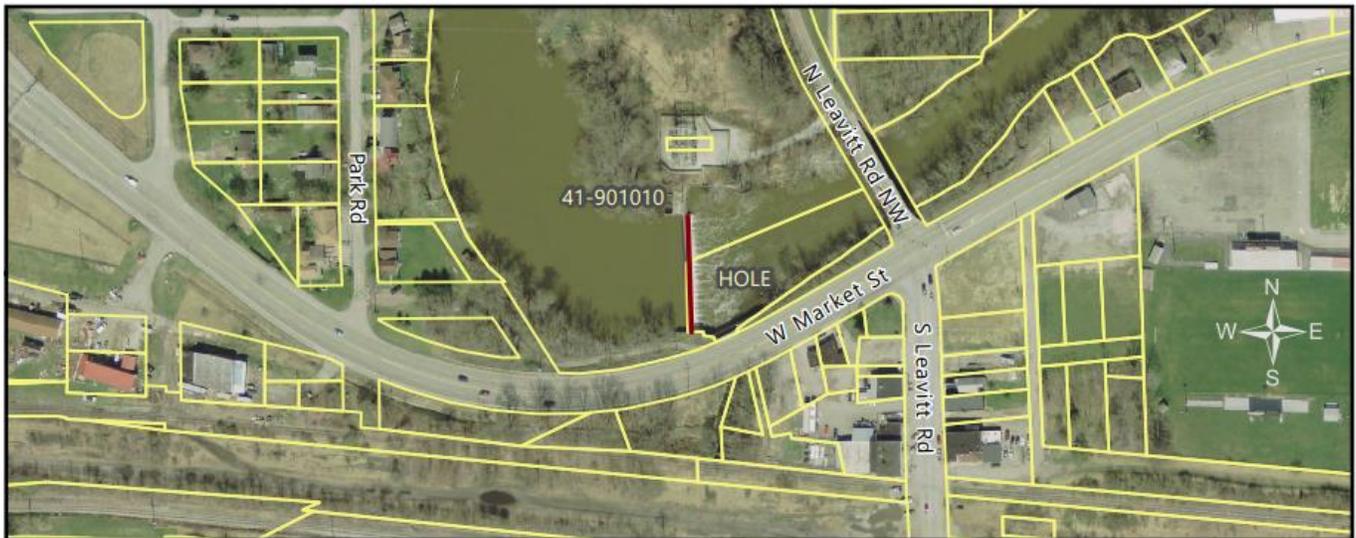
Figure 2: Location of the Leavittsburg Dam (in red) in the Chocolate Run HUC-12 (image courtesy Eastgate).

Located in the Chocolate Run HUC-12 on the Mahoning River at approximately RM 42.99, the Leavittsburg Dam is a low-head earthworks dam in Warren Township and owned by Trumbull County MetroParks. The dam is approximately 8 feet tall (USACE, 2006) and is one of a series of low-head dams located along the Mahoning River mainstem that have been targeted for removal by Eastgate and nearby communities to restore free-flowing conditions and improve water quality and alleviate flooding in this reach. The Leavittsburg Dam has frequently been cited as a source of flooding in surrounding neighborhoods and its presence accounts for nearly 10 miles of backwater conditions on the Mahoning River mainstem.

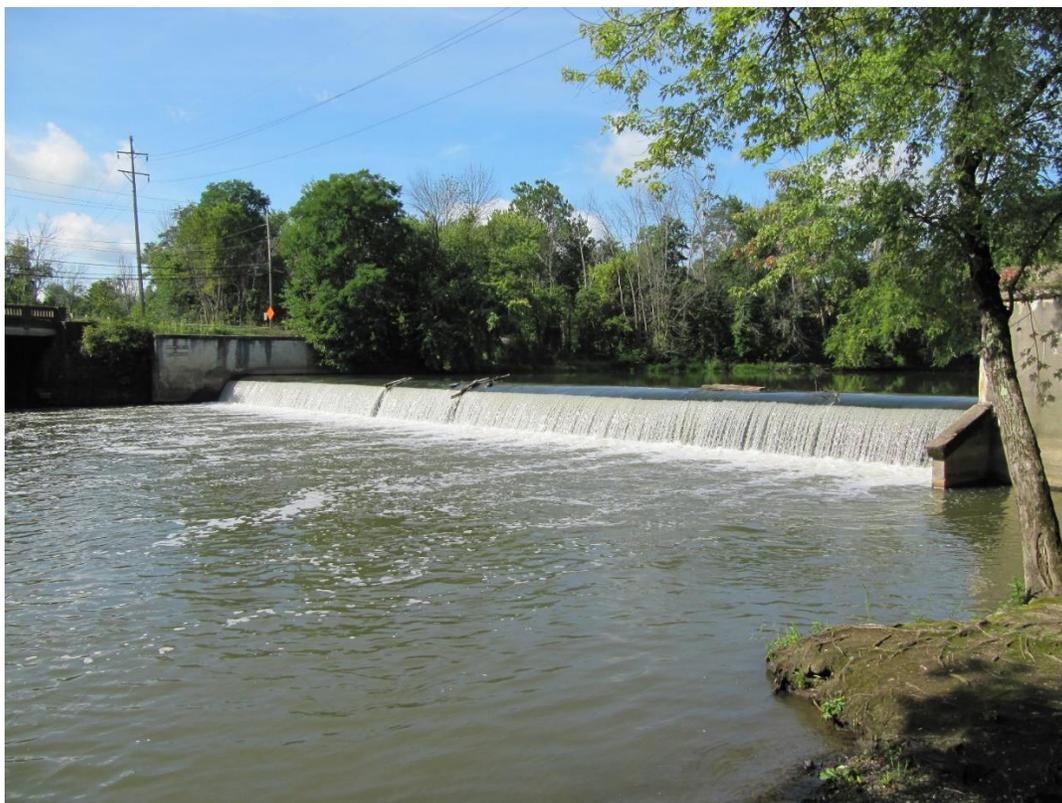
Figure 3: Photo of the Leavittsburg Dam looking upstream near the Canoe City MetroPark (photo courtesy Eastgate).

The area originally had a small dam upstream from the current dam site constructed in the early 1900s. The current Leavittsburg Dam was constructed a few years later and submerged the small upstream dam in the process. The Leavittsburg Dam's original use was to support an electric generation facility which has long been in disuse and has been replaced by an electrical substation still in use today. Trumbull County MetroParks reports that the dam and surrounding Canoe City MetroParks property is regularly submerged during seasonal floods.

The critical area also contains the Leavittsburg Dam, a low-head earthworks dam in Warren Township and owned by Trumbull County MetroParks as part of their Canoe City MetroParks facility. The dam is approximately 8 feet tall (USACE, 2006) and is one of a series of low-head dams located along the Mahoning River mainstem that have been targeted for removal by Eastgate and nearby communities to restore free-flowing conditions and improve water quality and alleviate flooding in this reach. The Leavittsburg Dam has frequently been cited as a source of flooding in surrounding neighborhoods and its presence accounts for nearly 10 miles of backwater conditions on the Mahoning River mainstem. Trumbull County MetroParks reports that the dam and surrounding Canoe City MetroParks property is regularly submerged during seasonal floods.

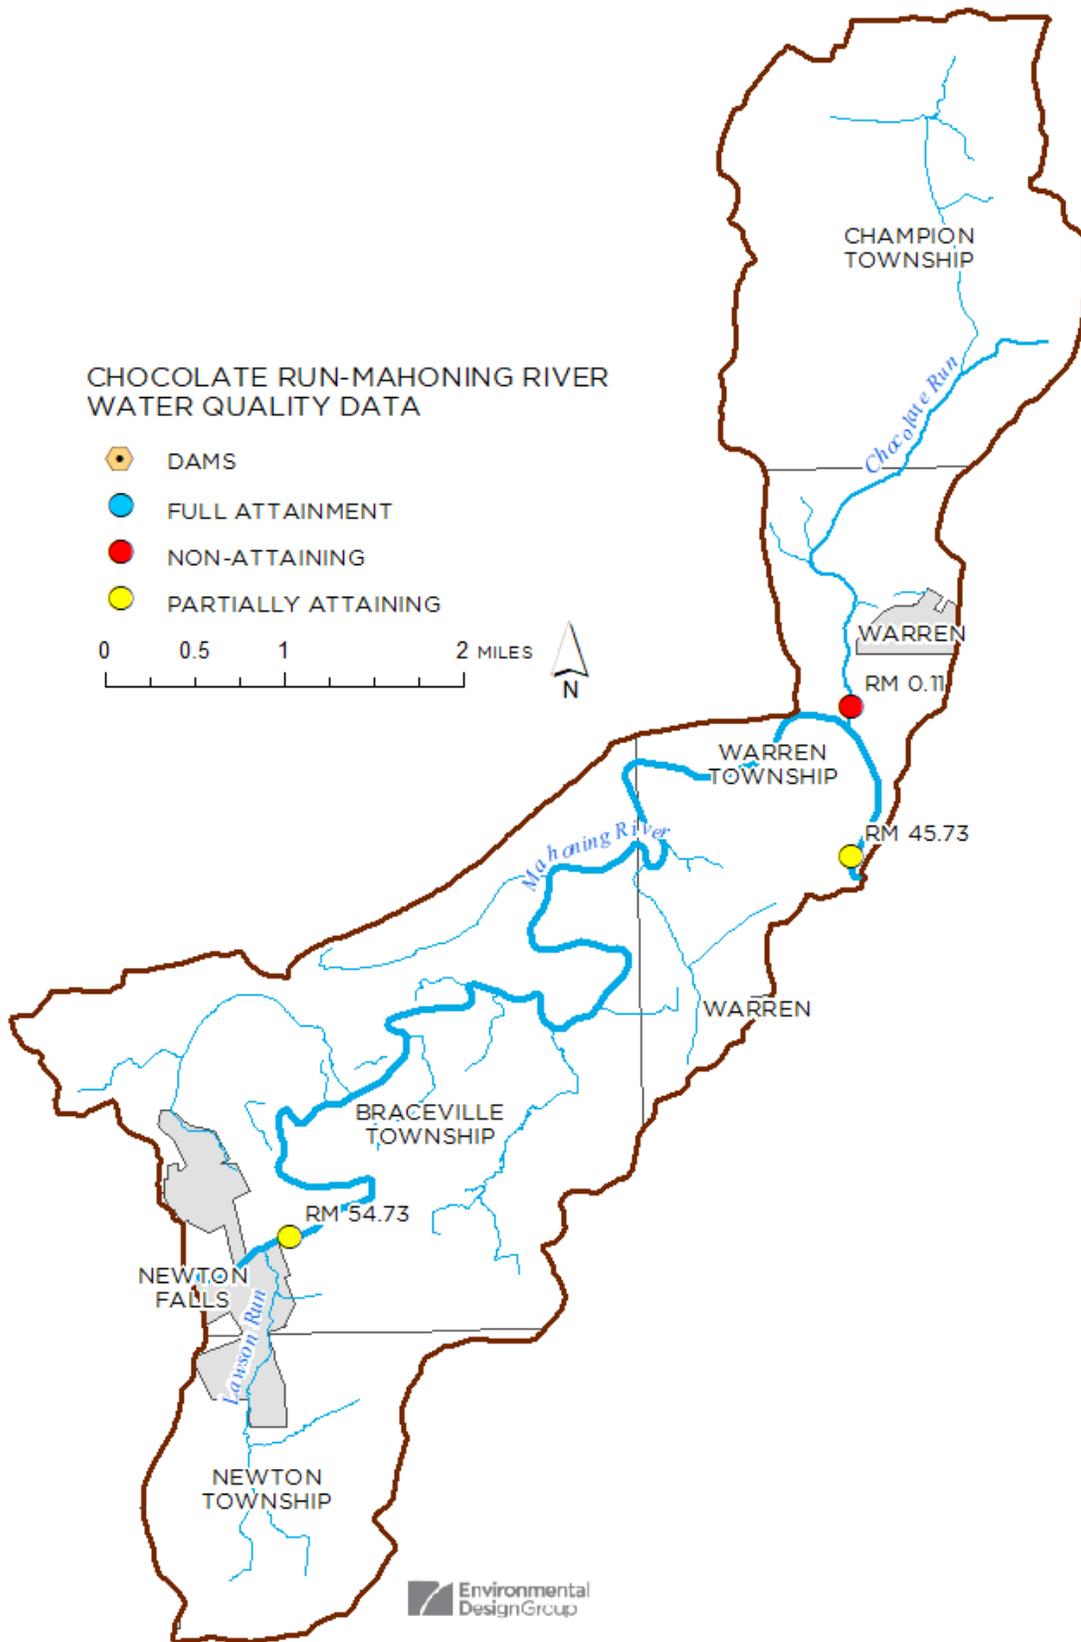
Monitoring was performed by Ohio EPA at three locations in the Chocolate Run HUC-12 in 2006; the Mahoning River downstream of its confluence with the West Branch Mahoning River and I-80 (RM 54.73), the Mahoning River upstream of the dam at Leavittsburg (RM 45.73), and on Chocolate Run at Eagle Creek Road (RM 0.11). Additional monitoring was performed in 2013 at the RM 45.73 location. None of the monitoring points were in full attainment of the WWH aquatic life use. The below figure shows the sampling locations and attainment status of each monitoring point.

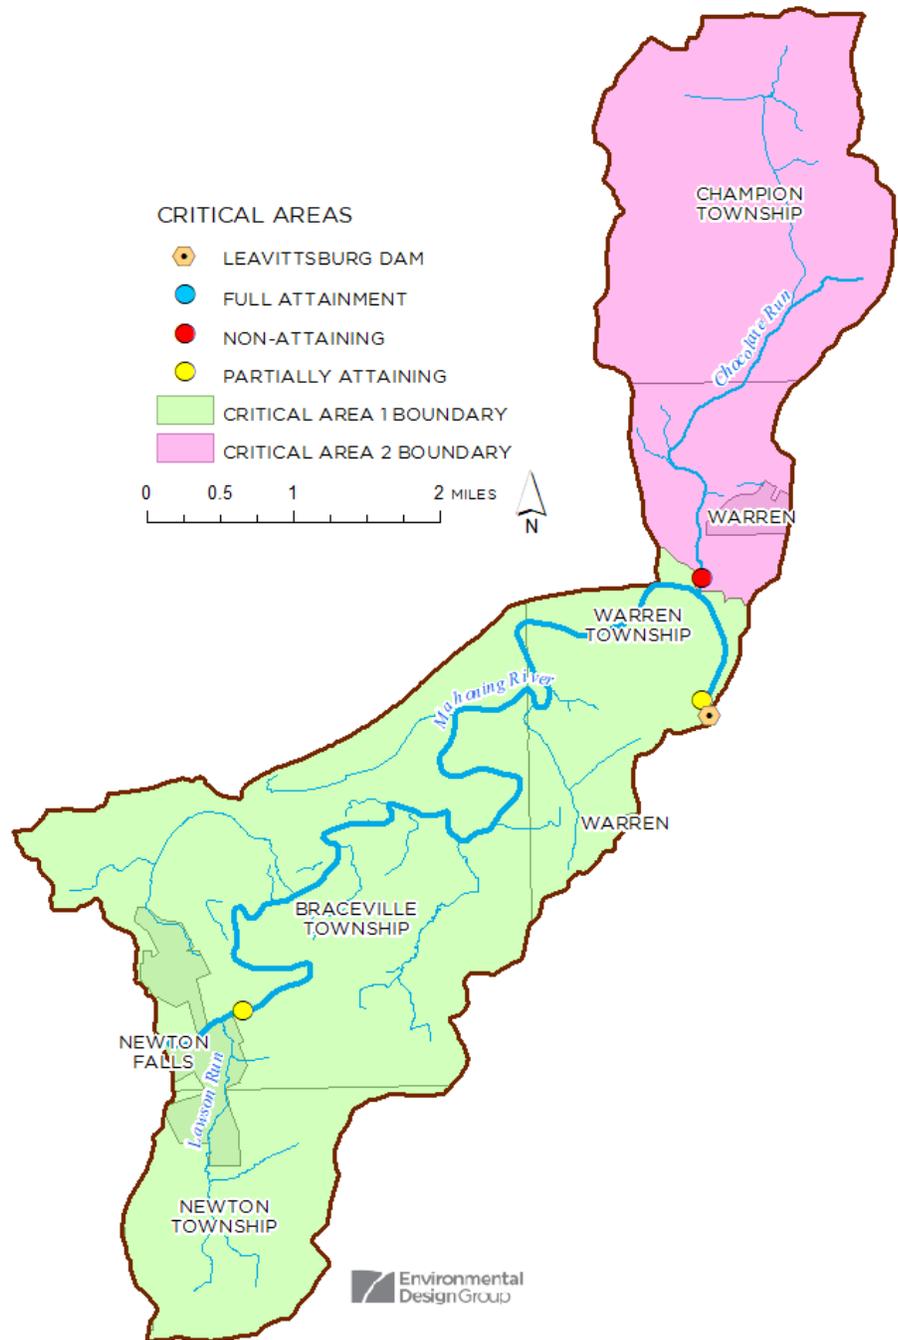
- Critical Area 1: Mahoning River mainstem and drainage
- Critical Area 2: Chocolate Run Tributary and drainage
